4.0 LAUNCH

4.1 PRE-LAUNCH SSV/PAD DEBRIS INSPECTION

4.2 FINAL INSPECTION

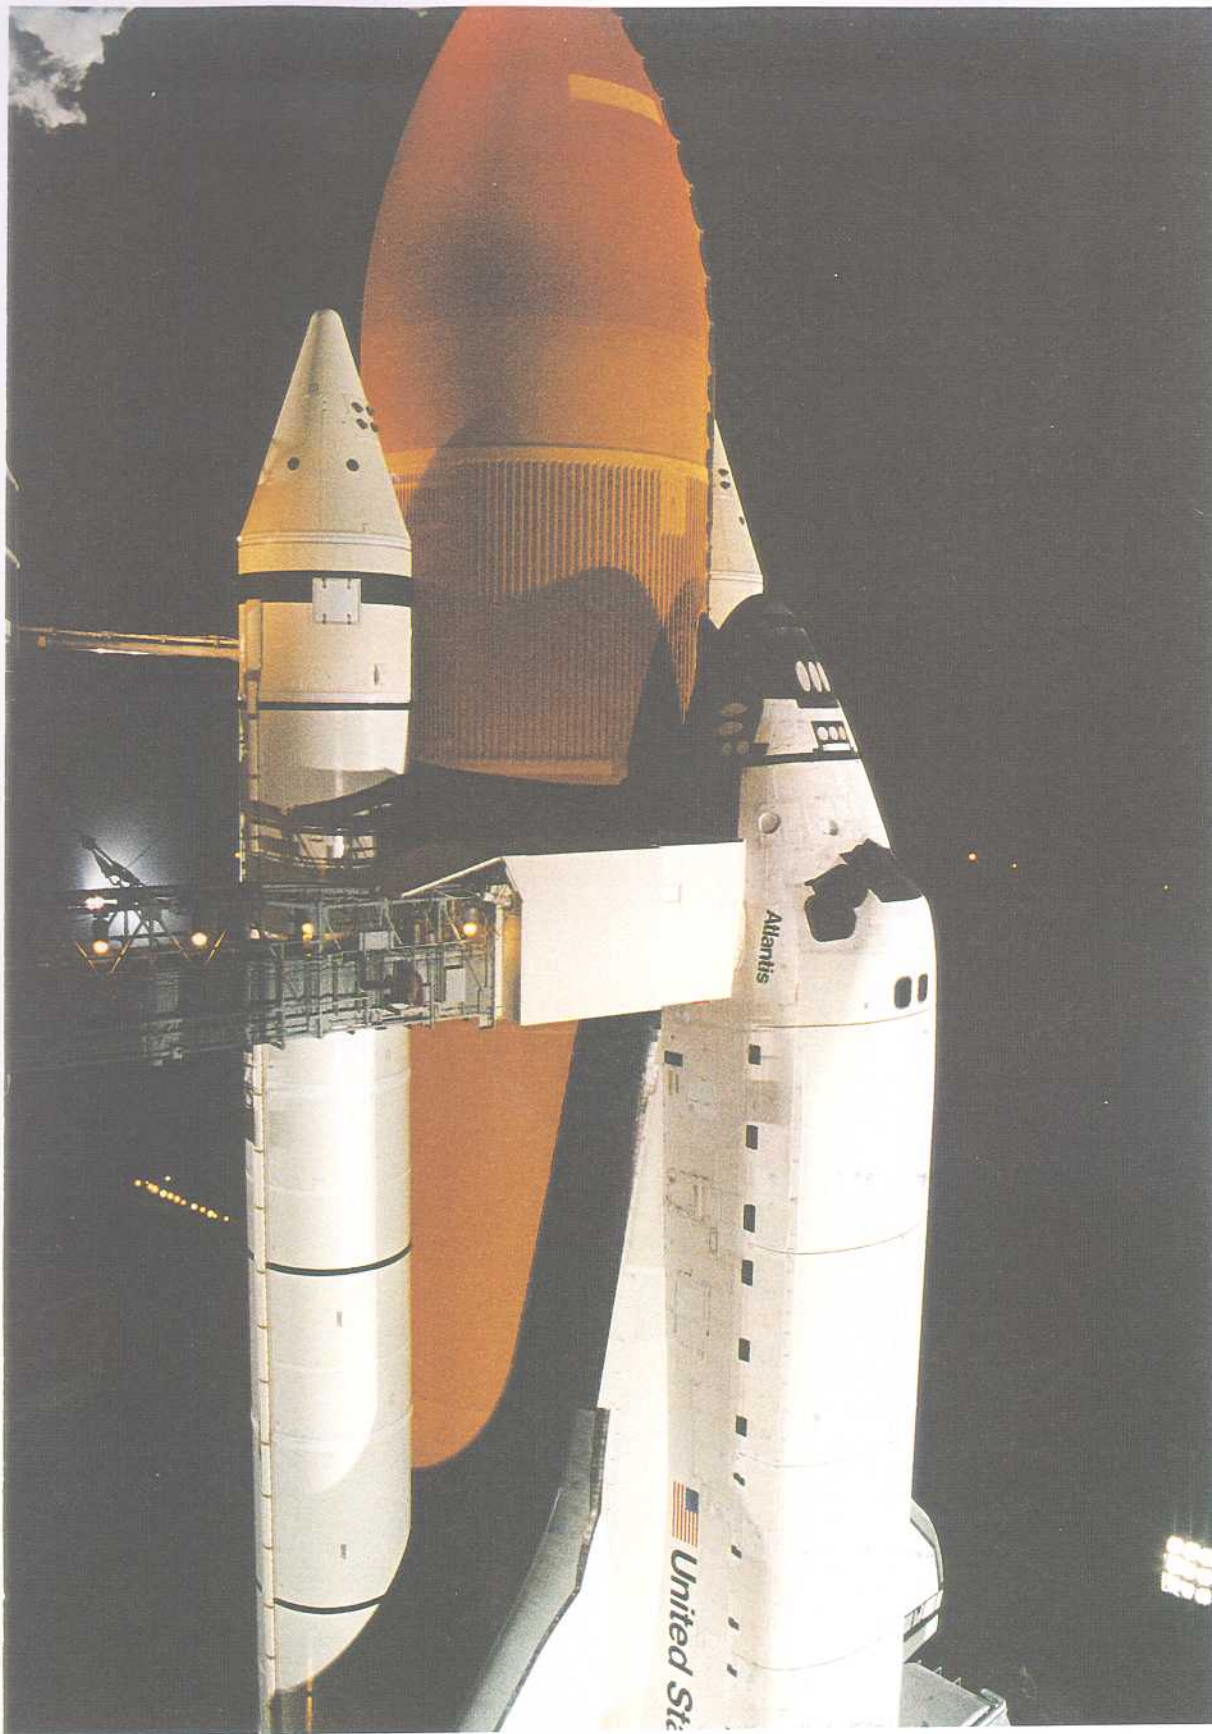
Photo 5: ET LO2 Tank and Intertank

During this fourth cryoload, the External Tank was in excellent condition. The Final Inspection Team observed light condensate on the LO2 tank acreage. Surface temperatures averaged 57 degrees Fahrenheit. No TPS anomalies were detected.

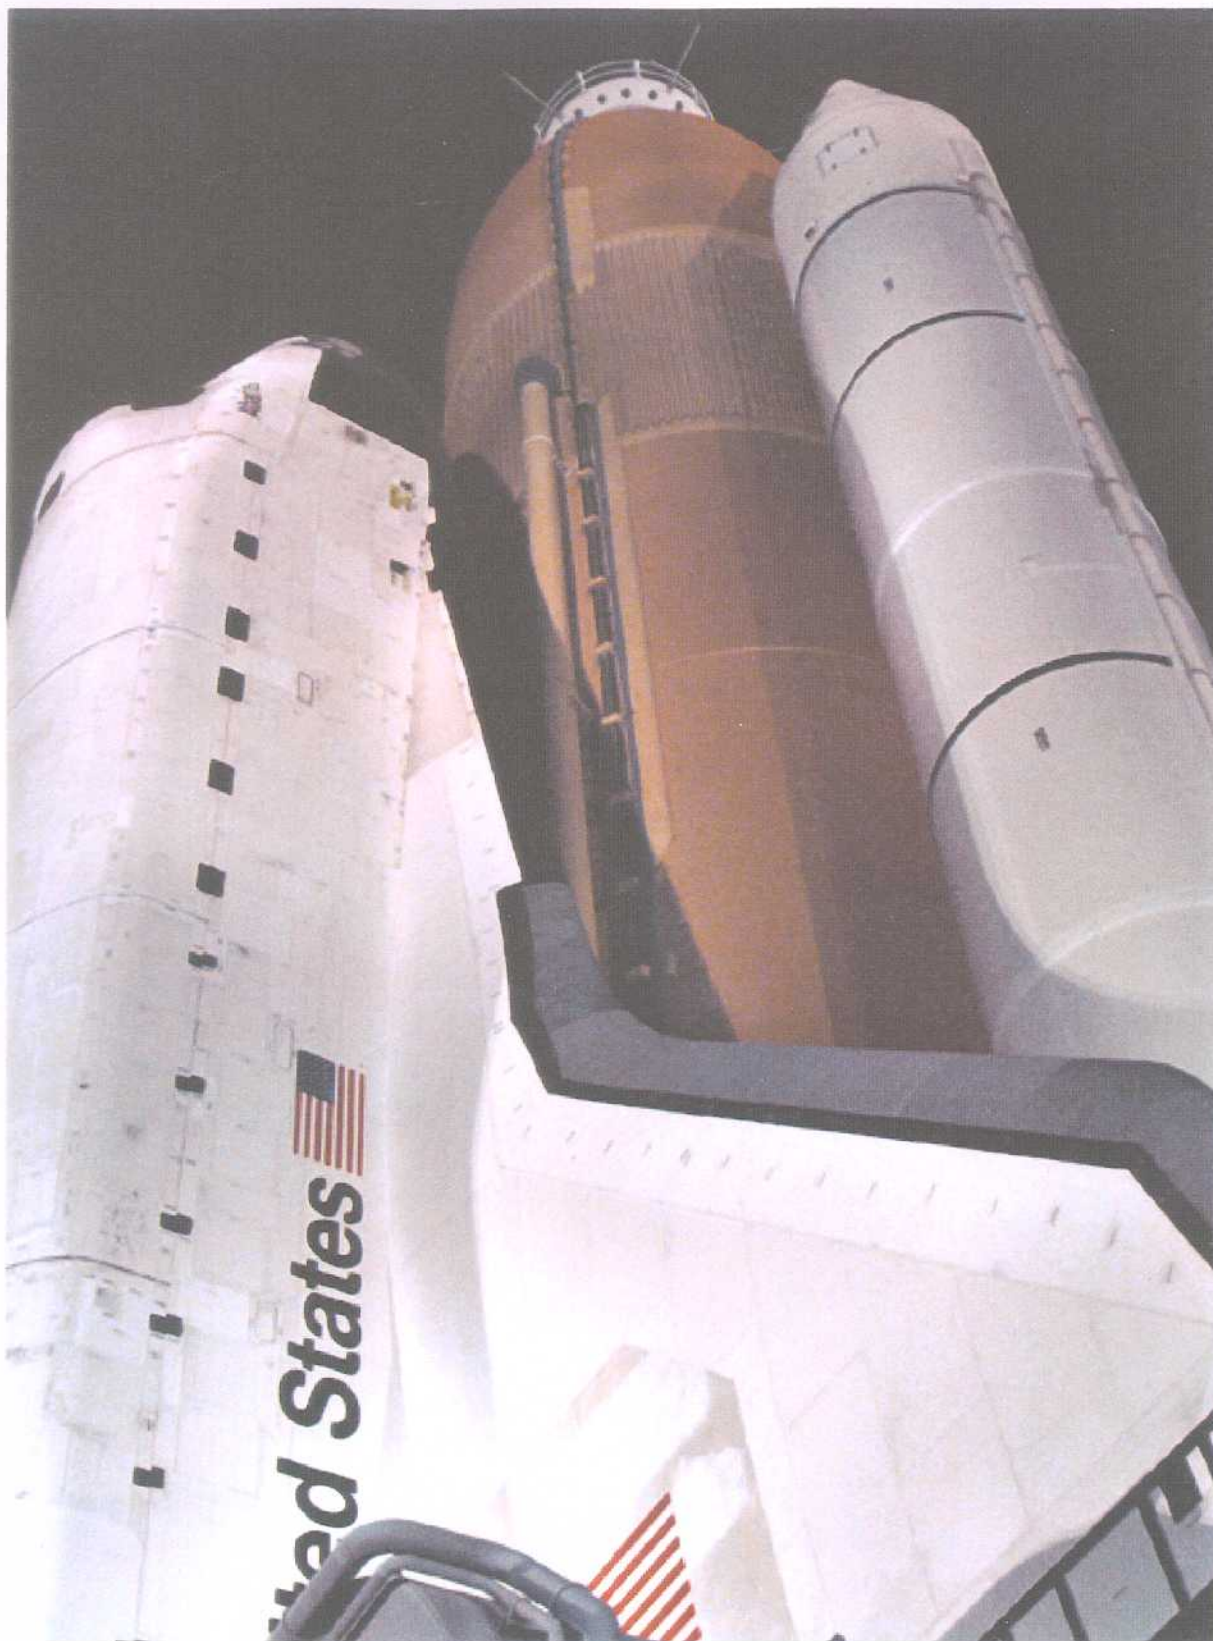
Photo 6: LH2 Tank Acreage

Light condensate was present on the LH2 tank acreage. Surface temperatures ranged from 58 to 66 degrees Fahrenheit. There were no acreage TPS anomalies.

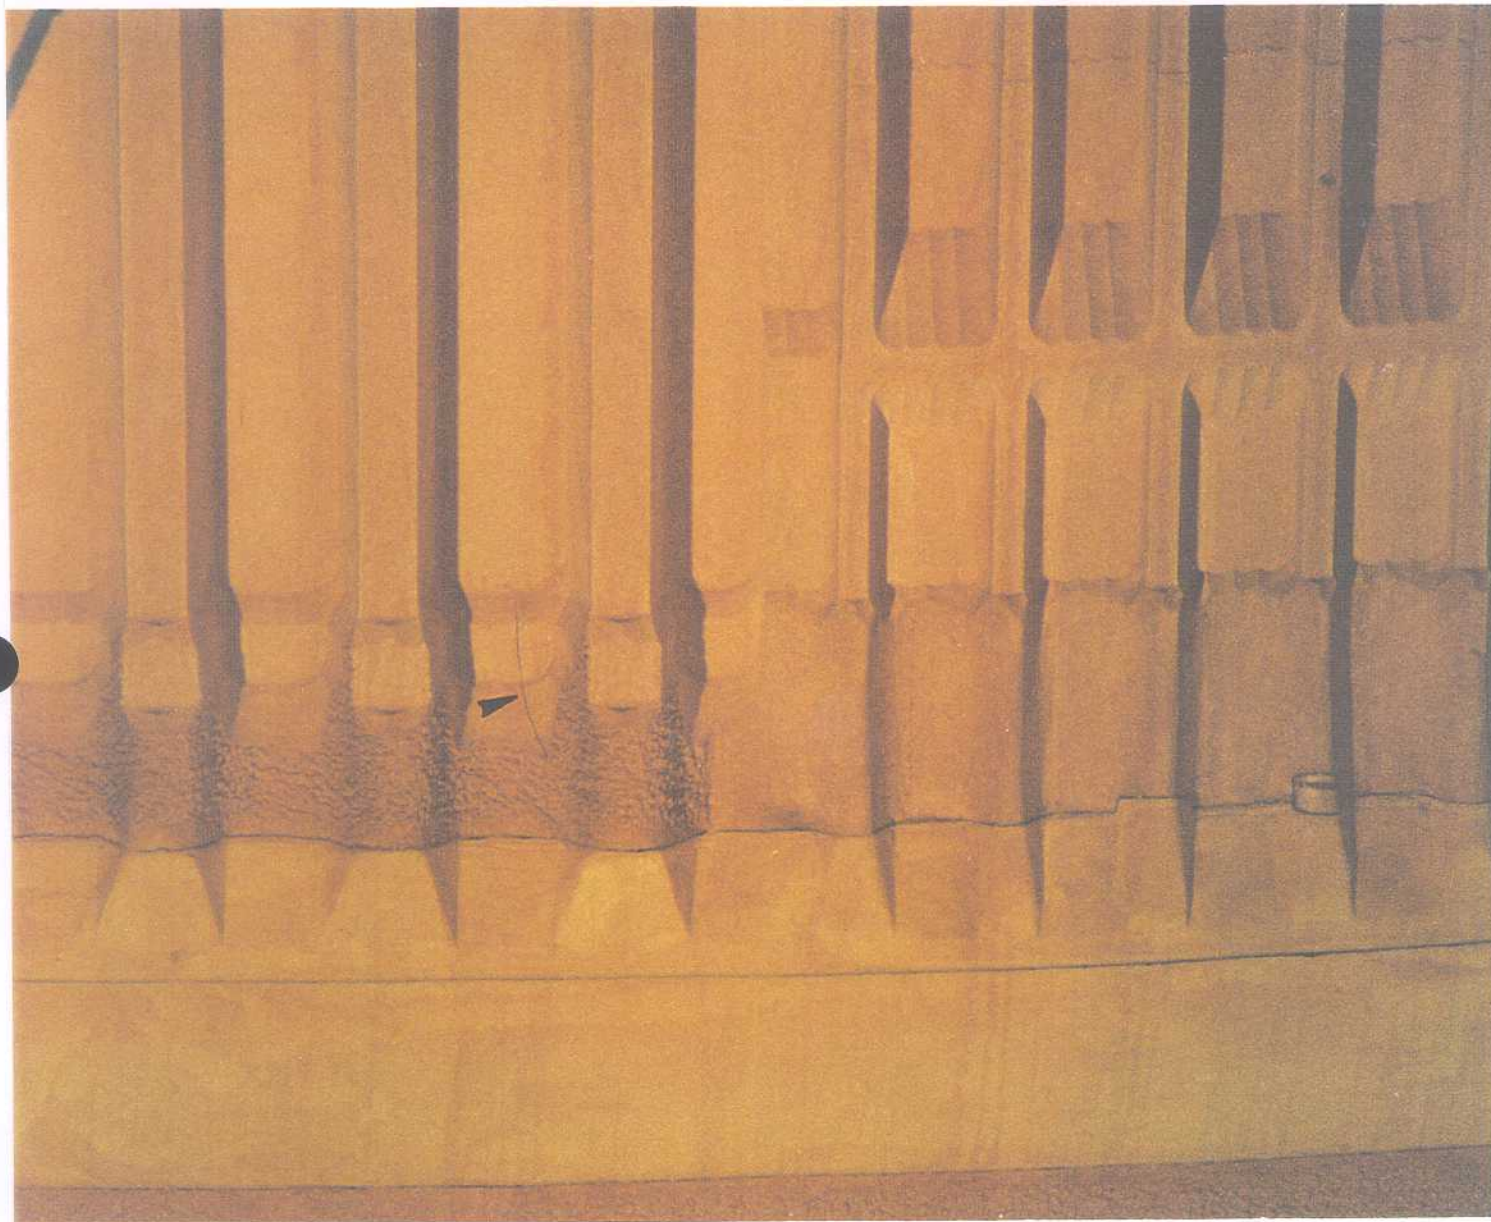
Photo 7: Cracks in Intertank Stringer Valleys

No significant anomalies were present in the intertank TPS. The 14 stringer valley TPS cracks detected during the previous cryoloads had increased to a total of 15 with the appearance of an additional hairline crack in the -Y-Z quadrant. Ice and frost accumulations on the GUCP were typical.

No significant anomalies were present in the intertank TPS. The 14 stringer valley TPS cracks detected during the previous cryoloads had increased to a total of 15 with the appearance of an additional hairline crack in the -Y-Z quadrant.

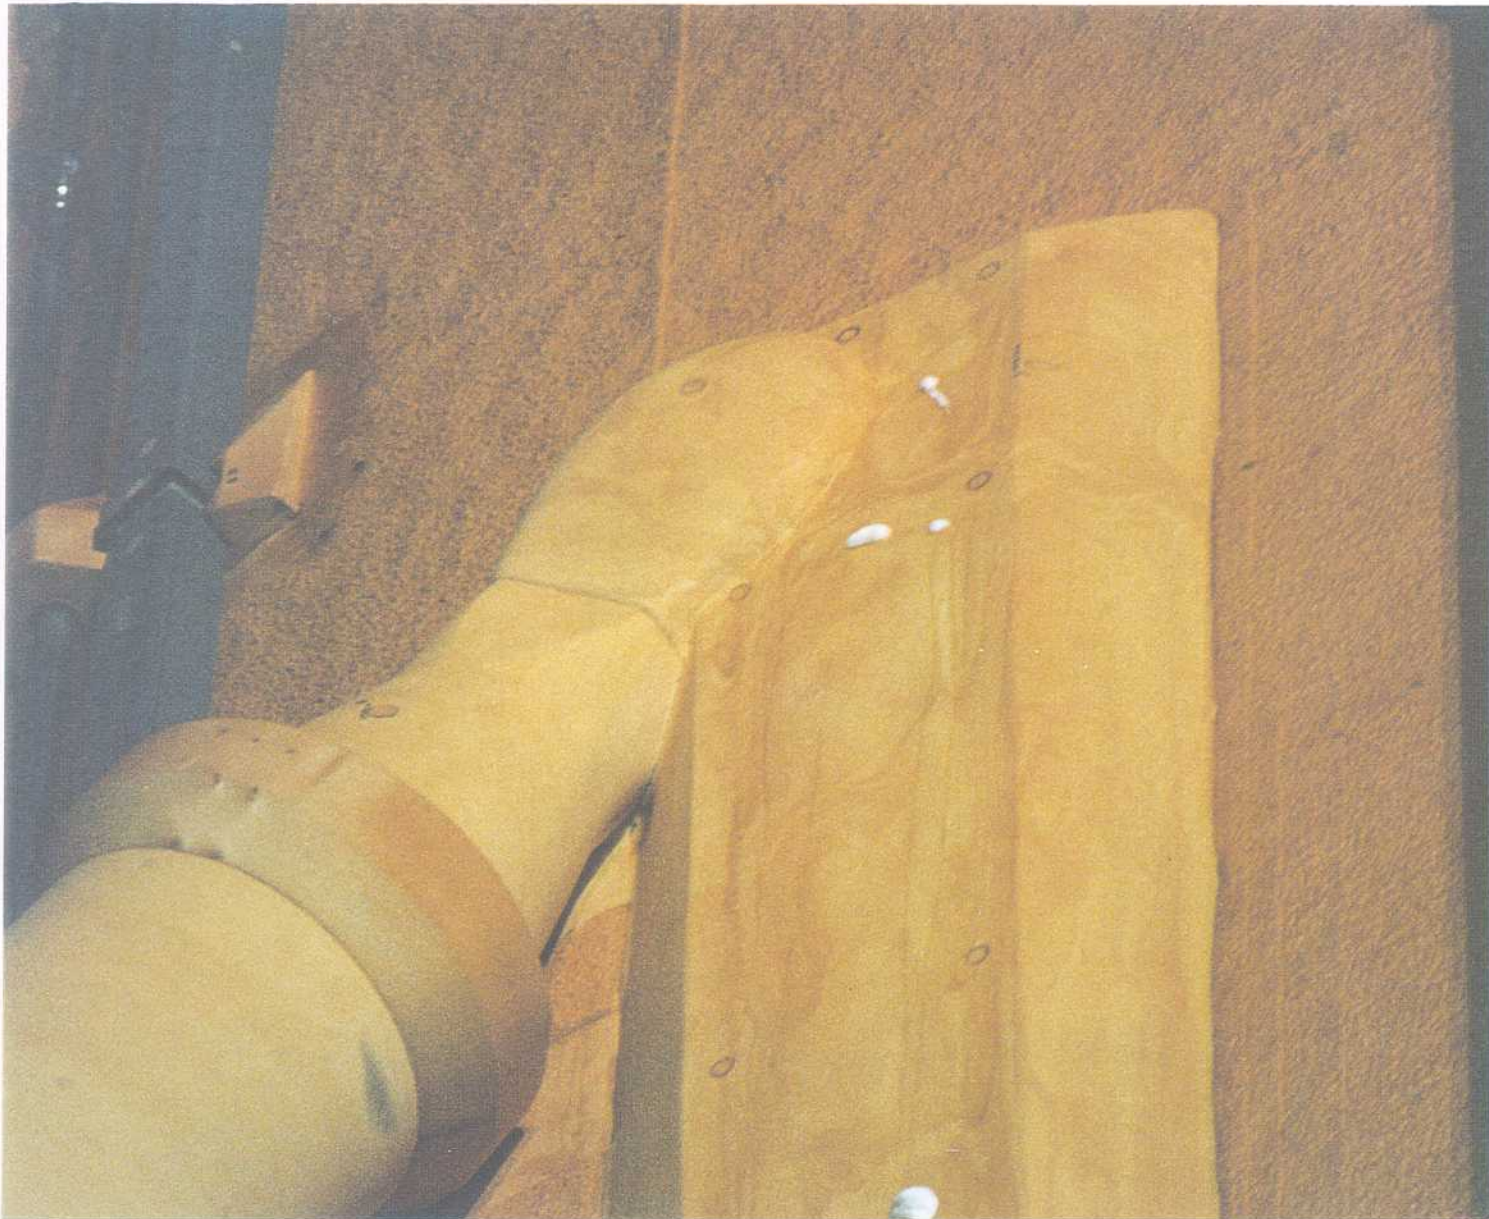
Photo 8: ET +Y Longeron

As typically happens during multiple cryogenic loadings, randomly scattered thermal shorts produced small ice/frost formations as seen here in the +Y longeron closeout foam

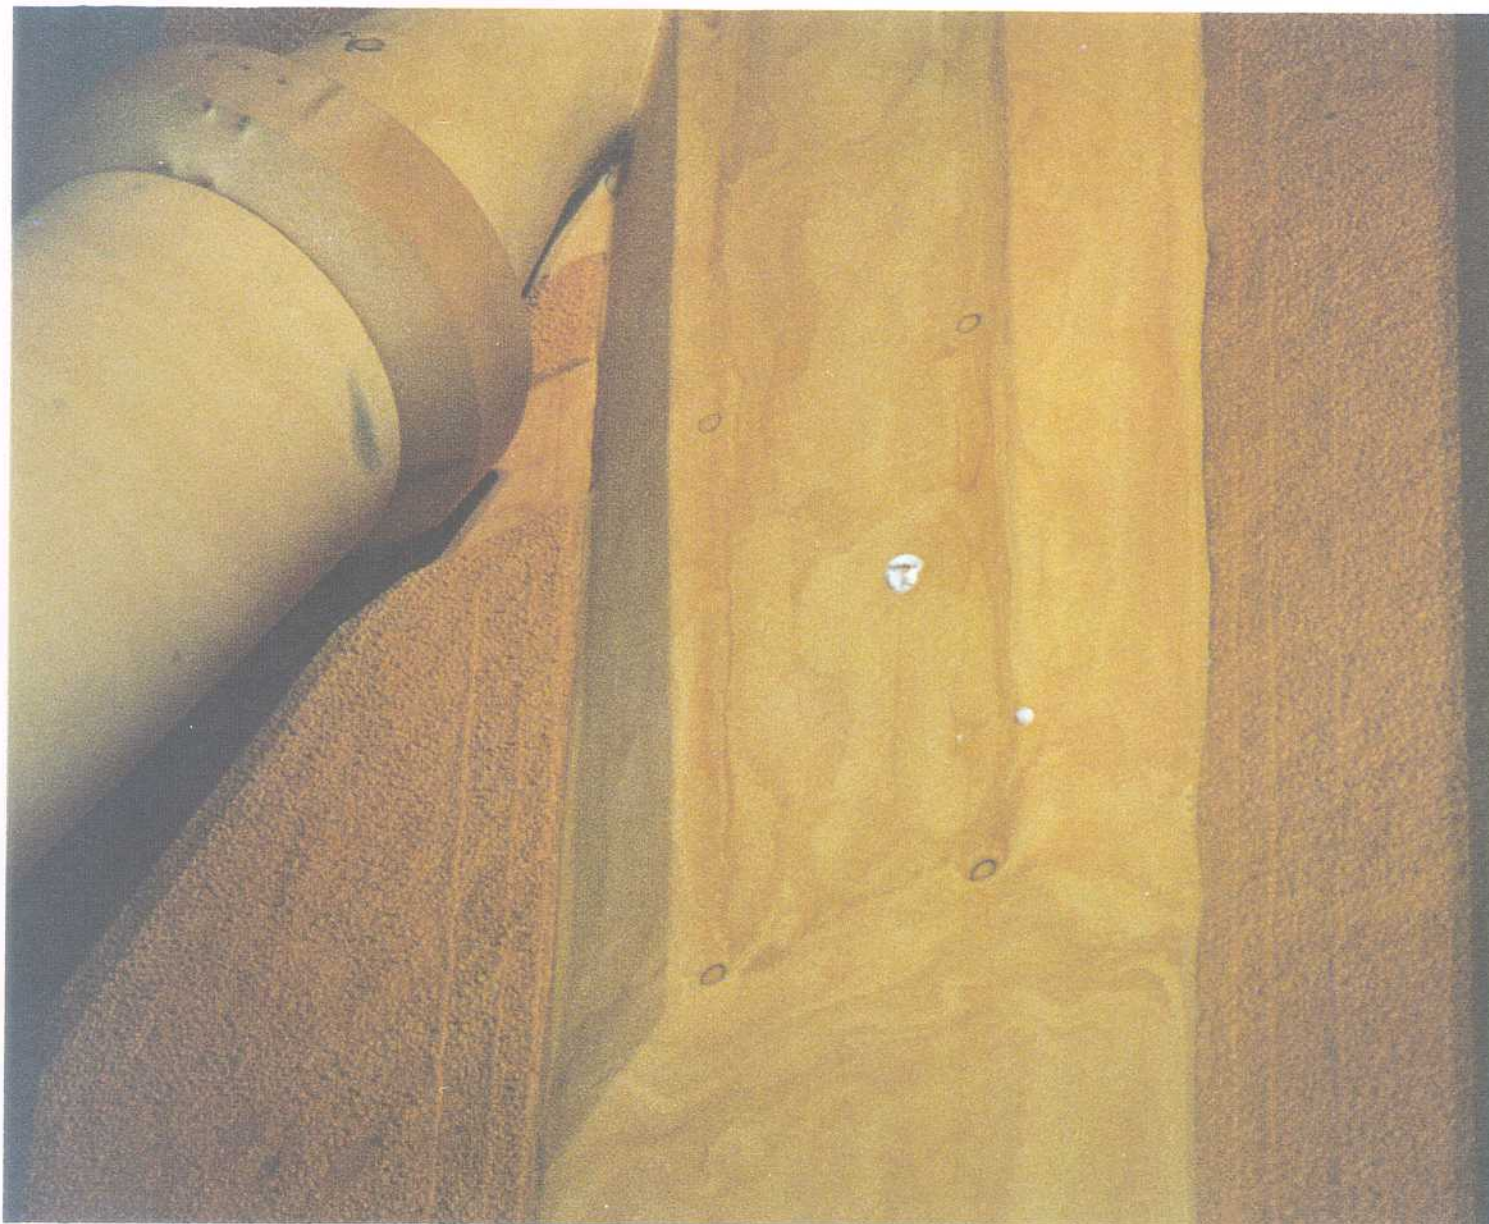
Photo 9: ET +Y Longeron TPS

Due to the long interval between launch attempts, the cracks in the +Y longeron closeout TPS were re-assessed. PR ET-102-TS-0012 documented the location and size of the cracks, which were accepted by MRB use-as-is for flight. The condition of the cracks during any subsequent cryoloadings would be compared to this baseline.

The cracks and ice/frost accumulations in the +Y longeron closeout TPS as documented prior to tanking had not changed. Therefore, no new IPR was required.

The cracks and ice/frost accumulations in the +Y longeron closeout TPS documented prior to tanking had not changed. Therefore, no new IPR was required.

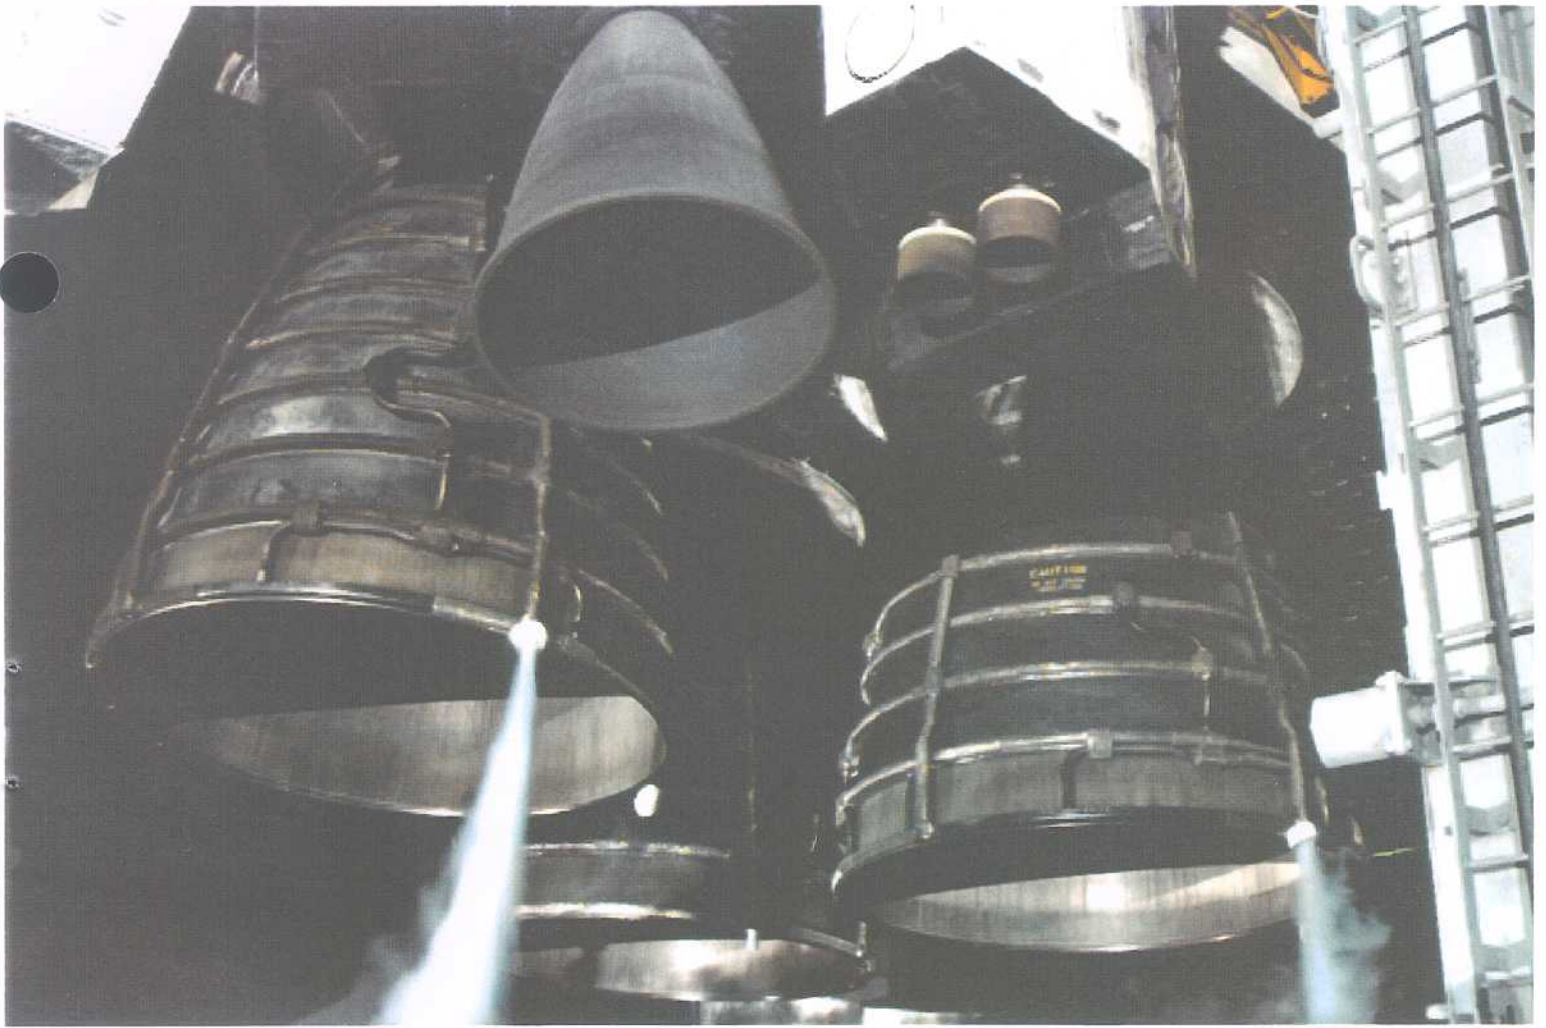
Photo 10: Overall View of SSME's

No Orbiter tile or RCC panel anomalies were observed. The RCS thruster paper covers were intact but four covers (F2U, F3L, F4D, R1R) were discolored. Ice/frost had formed on the SSME #1 and #2 heat shield-to-nozzle interfaces. The SSME #3 heat shield was dry.
